Technical Bulletin

Subject: Refacing Cylinder Heads
with Use of Tool 9526

Number
9404

Models Affected: *911 Carrera 2/4 Model Years '89 (K), '90 (L) and '91 (M) up to engine number:
62 M06836, M64.01 - Manual Transmission
62 M52757, M64.02 - Tiptronic*

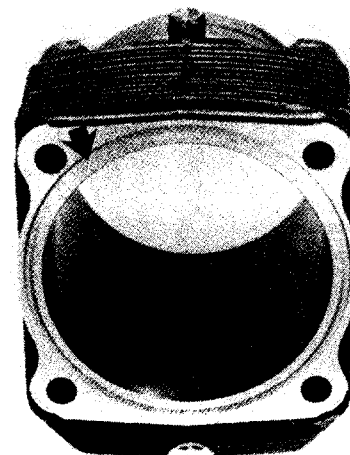
Figure 1

IMPORTANT: Replacement piston and cylinder sets have a groove to accommodate a seal between the cylinder head and cylinder mating surface (Figure 1). Effective immediately, only the steel sealing ring, Part Number 964 104 115 20 is to be used during repairs. This information also applies to engines produced after the above mentioned engine numbers.

When installing the cylinder head to the cylinder, the steel sealing ring must be fully installed in the groove of the cylinder. Sparingly use light grease to hold the ring in the cylinder during installation.

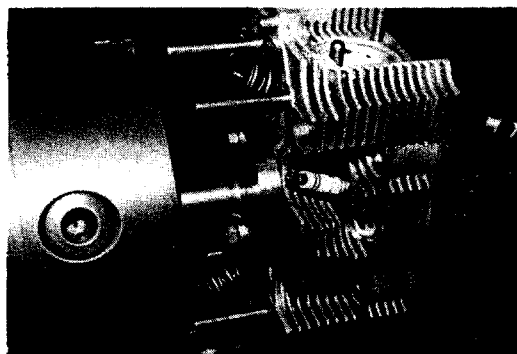
Figure 2

1. Clean cylinder heads (do not sandblast assembled cylinder heads).
2. Install special tool 9526 on the short 8mm cylinder head studs. Tool cut-out faces intake valve (Figure 2).

Before installation into the lathe, be certain special tool 9526 is not damaged or bent (ie. shipping damage, dropping, nicks, etc.).

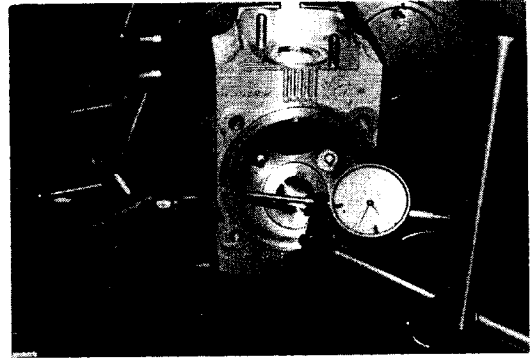
Figure 3

4. Check lateral and radial cylinder head run-out with dial gauge (Figure 3). If necessary, lateral run-out must be adjusted on lathe. Radial run-out can be adjusted by loosening the mounting nuts and repositioning the cylinder head on special tool 9526 as required.

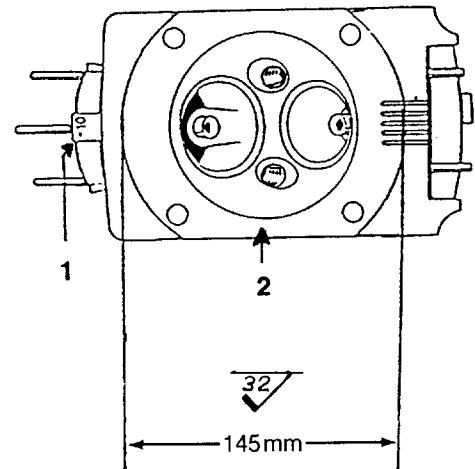
Figure 4

5. Machine $0.10 \pm 0.02\text{mm}$ from inner surface (arrow 2 in Figure 4). The diameter of the machined surface must be 145mm (Figure 4). A surface quality standard of 32 micro-inches must be maintained. Machining should be done with a cutting tool at right angle to the work. The cylinder head surface may only be machined a maximum of 0.20mm.

When machining is complete, the mating surface of the cylinder head to cylinder must be 145mm in diameter.

6. Mark cylinder head with -10 or -20 appropriately on intake flange (arrow in Figure 4).
